Thomson PS27108 CTC187BF2

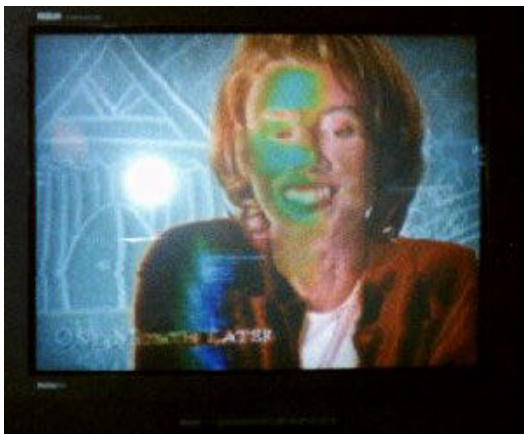
Pix 1. Highlighted Flesh tones look cyan

Pix 1 Symptom: Appears to have a chroma demodulation defect. Approximately 180 degree phase shift in chroma signals that contain flesh tones. This phenomena occurs only on two channels while using the main tuner. Using the video input to the television from a VCR and receiving the same channel, the problem is not evident. The customer was using an external television antenna with moderate signal strength. The symptom only affects the bright flesh tone parts of the picture.

Cure: At one point earlier someone had replaced the EPROM for a "Dead Set" condition. No one bothered to realign the tuner. The clue was every of the alignment parameter was 31. The tuner needed a complete alignment. Realignment was accomplished by using the tuner alignment jig by Thomson TAG-001, the trouble was corrected.

Note: It is not recommended that the tuner alignment parameters be copied from any other television set even if you have the same chassis number and suffix. Every tuner is different. The tuners may have the same parts, and component physical locations but there are subtle differences in the distributed capacitance within coils, lead dress, etc... These differences are the reason we need the individual alignment parameters. This tuner operates in frequencies from 55.25 Mhz to 874 Mhz. A slight tweak or an innocuous bend in a coil will effect it inductance and distributed capacitance within the coil. These factors will negatively effect the performance of these tuners if not compensated for by correct alignment.

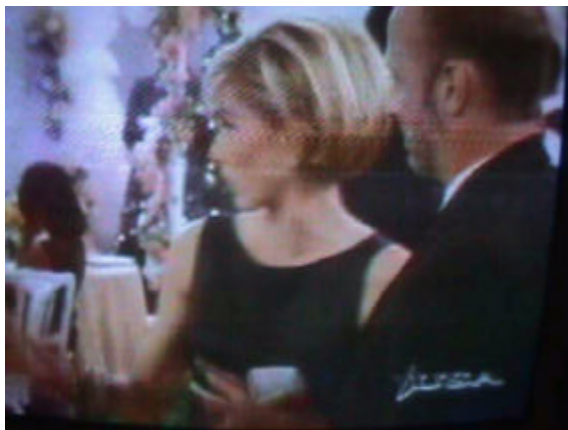
Pix 2. Adjacent channel interference.

Pix 2. Symptom: Adjacent channel interference on several channels. This photo is difficult to see the symptom. But if you look very closely you can see the VBI bar at the ear lever of the subjects in the photo. This customer is on CATV. The symptom was originally declared as a CATV related problem. But CATV was ruled out when the problem was not visible on a second television.

Note: **This trouble was not visible on all channels, or when an outside antenna was used.**

Cure: In this unit the alignment appeared correct. No alignment errors could be found. When measuring the AGC voltage at U1001(12) or at the C2306(+) the voltage never varied from a "no signal" to a "have signal" condition. A choice had to be made to replace the Mixer/Oscillator U7301, or the Jungle IC1001. It was decided to replace U7301. This was a lucky guess and it corrected the the symptom.
