CTC211 Chassis Configuration

**SCAN RATE CONVERTER
MODULE**

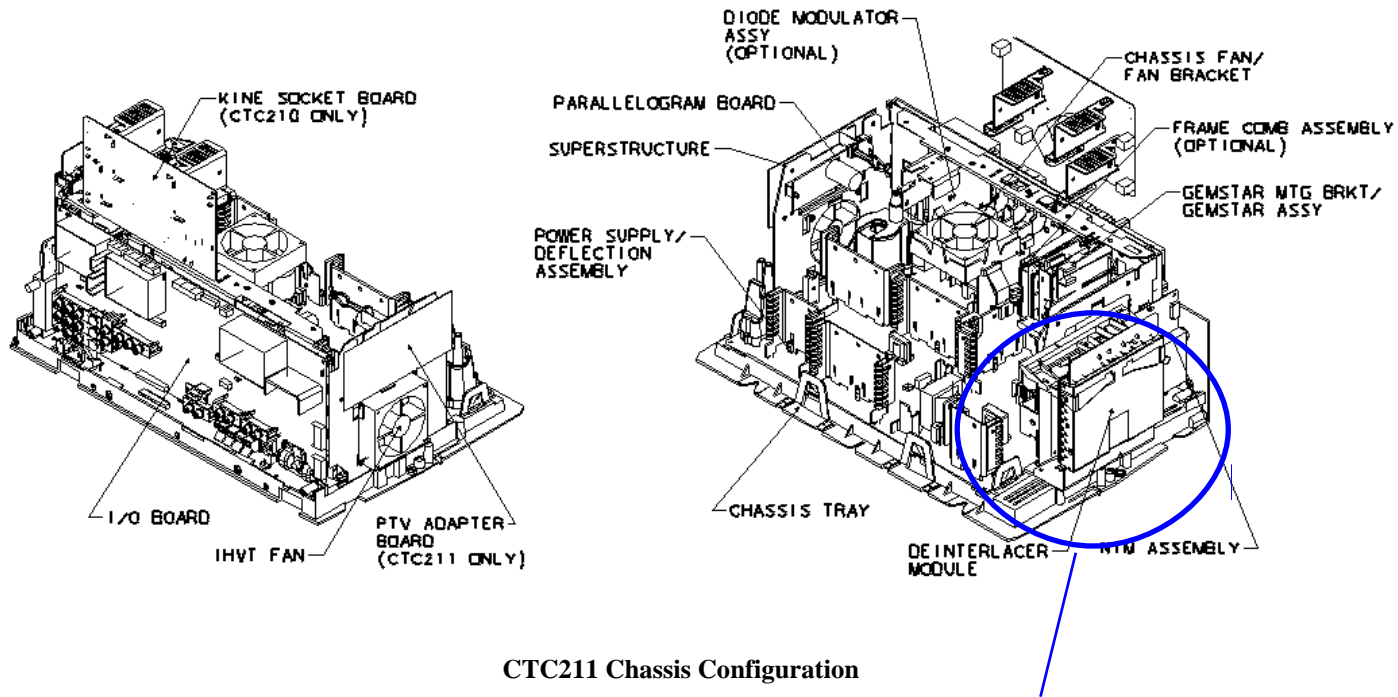
PROBLEM: PICTURE HAS A THIN BLUE LINE ON LEFT SIDE OF SCREEN 1/4" IN DIAMETER ON MOST SCENES. REPLACING SCAN RATE CONVERTER(PART NUMBER 254349) FIXES PROBLEM. THE SCAN RATE CONVERTER IS SIMILAR TO THE FLEX CONVERTER IN HITACHI UNITS.
